Airfield Damage Repair Modernization Program

AM2 Brickwork Pattern Evaluation

December 2016

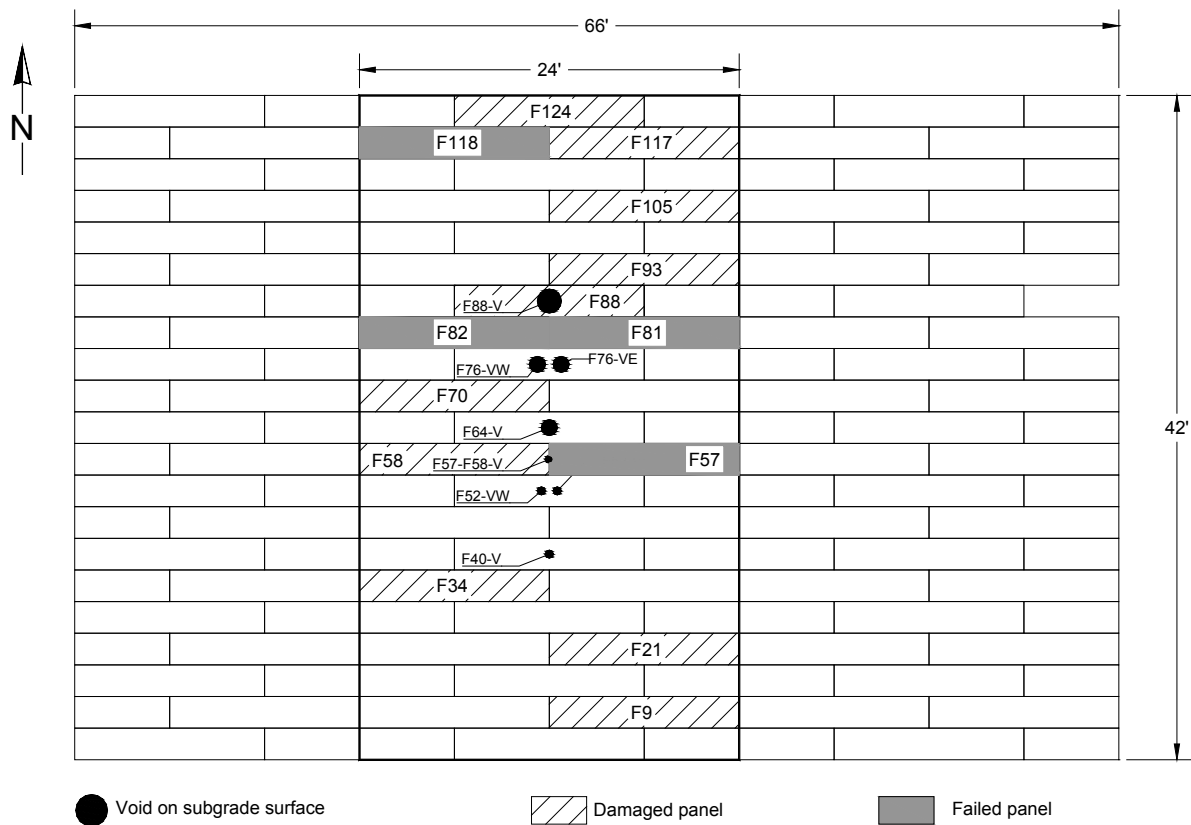
Figure 4.1. Layout of damaged and failed panels in the F-15-V item.

Trafficking of the F-15E-V test item began on July 9, 2013. No panel damage was noted until 32 passes were reached. Panel F70 had a 1/8-in. corner curl in the southeast corner. After 240 passes, Panel F81 failed when the upper underlap rail broke (Figure 4.2), allowing separation at the joint with F82. Panel F105 also developed a 1/8-in. corner curl in the southwest corner. After 496 passes, most panels with south corners

located on the traffic centerline developed 1/8-in. corner curls. Panel F81 had an 11-in.-long top skin tear after pass 548. The skin tear began near the southwest corner and propagated along the top flange of the female hinge. The loose piece of skin was posing a risk to the tire and was cut for maintenance.

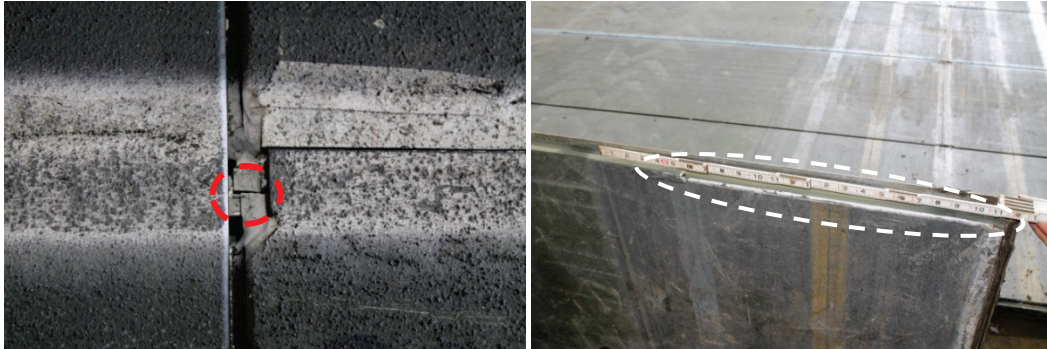
Figure 4.2. Broken upper underlap rail (left) and top skin tear (right) in F81.

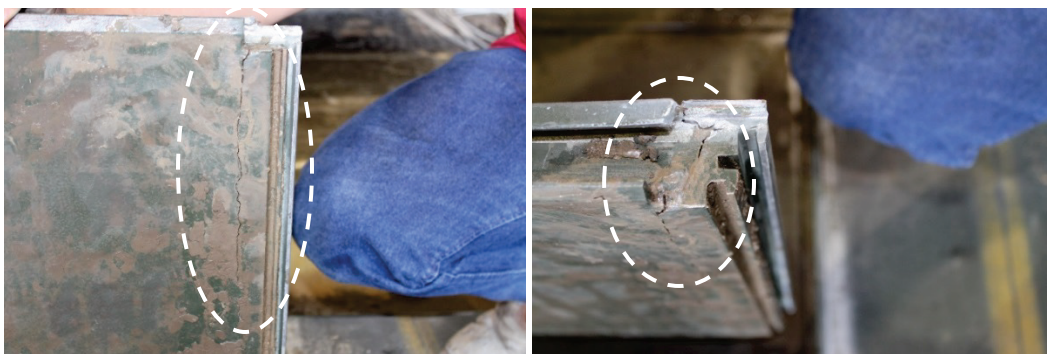
After 643 passes, Panel F118 failed when a 5-in.-long crack developed along the weld of the overlap end connector, causing the end connector to separate from the panel (Figure 4.3). Panel F82 had a 7-in.-long top skin tear along the top flange of the female hinge after pass 794. The loose piece of skin was removed to prevent a tire hazard. Panel F57 failed after pass 794 when the upper underlap rail broke. A 6.5-in.-long top skin tear had also developed.

Figure 4.3. Broken end connector in F118.

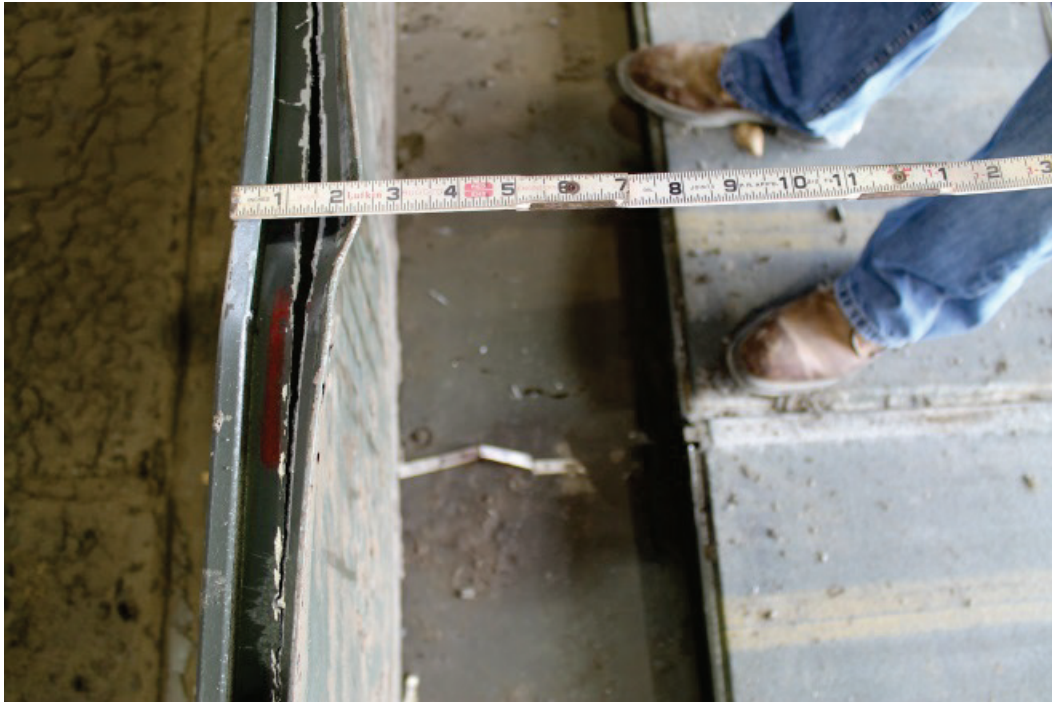
When the panels were removed after trafficking, additional damage was noted. Cracking along the center of the female hinge on Panel F124 had developed. The end connector weld crack on the bottom surface of Panel F118 was 10 in. long, starting at the female hinge connector side (Figure 4.3). Panel F88 developed cracking along the center of the female hinge with the bottom flange cracking and bent at the center (Figure 4.4). The overlap end connector weld on Panel F58 had cracked from the top surface to the bottom surface, and a 7-in.-long crack developed below the top flange of the female hinge. Table 4.1 summarizes post-traffic damage found in panels along with mat distresses and failures at various pass levels for the F-15E-V item.

Figure 4.4. F88 after removing from test section.

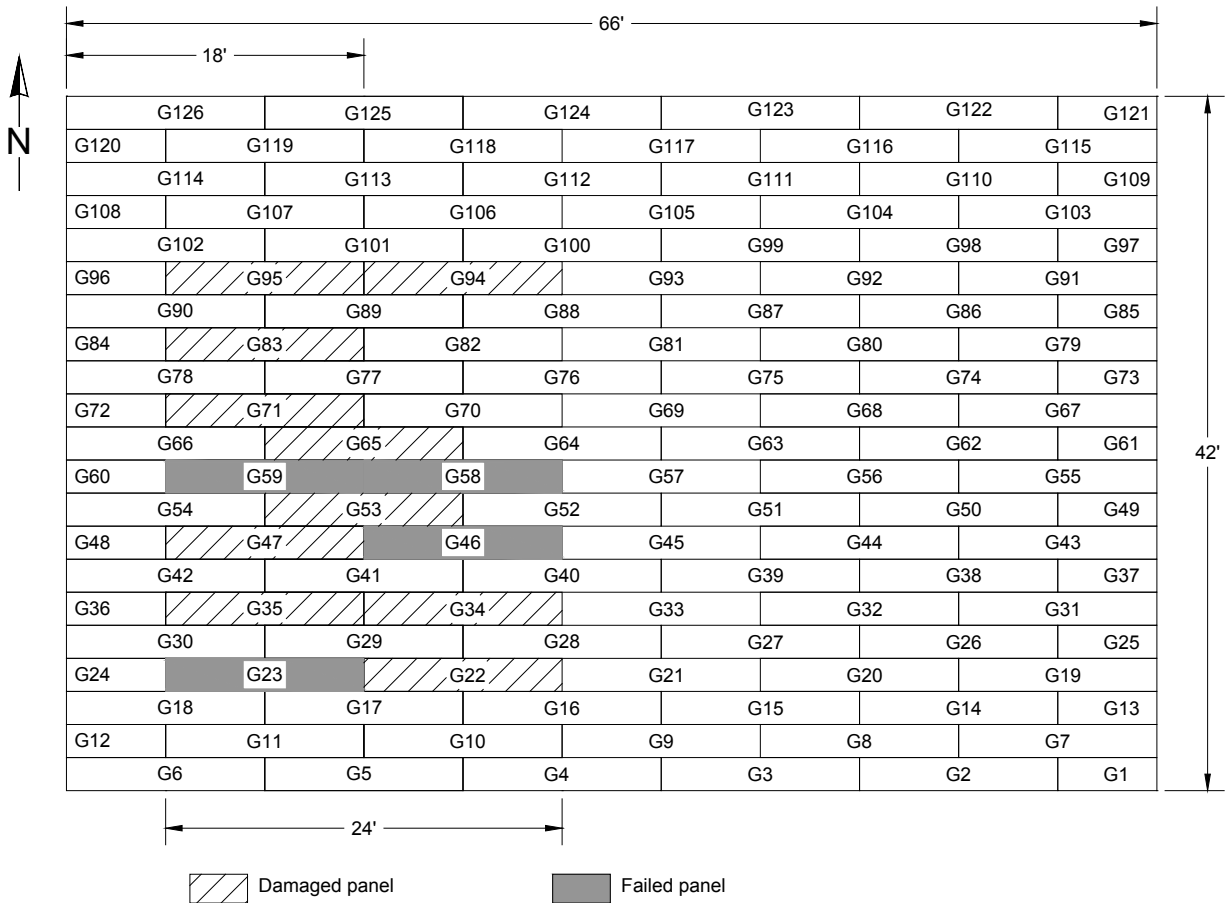
Figure 4.5. Layout of damaged and failed panels in the F-15E item.

Trafficking of the F-15E test item began on July 29, 2013. Figure 4.5 shows the layout of failed and damaged panels for the F-15E item after trafficking concluded. No panel damage was noted until 240 passes were reached. Panel G58 failed when the upper underlap rail broke, allowing complete separation with connecting Panel G59 (Figure 4.6). Several panels with their joint along the traffic lane had a 1/16- to 3/16-in. corner curl in the south corner. After 406 passes, Panel G23 failed when the end connector detached from the panel (Figure 4.7). A crack was visible throughout the length of the weld. Panel G58 had a 6-in.-long tear in the top skin along the top flange of the female hinge. The loose piece of skin was removed because it was posing a risk to the tire. Removal of this skin revealed a 6-in. crack in the male hinge of Panel G53.

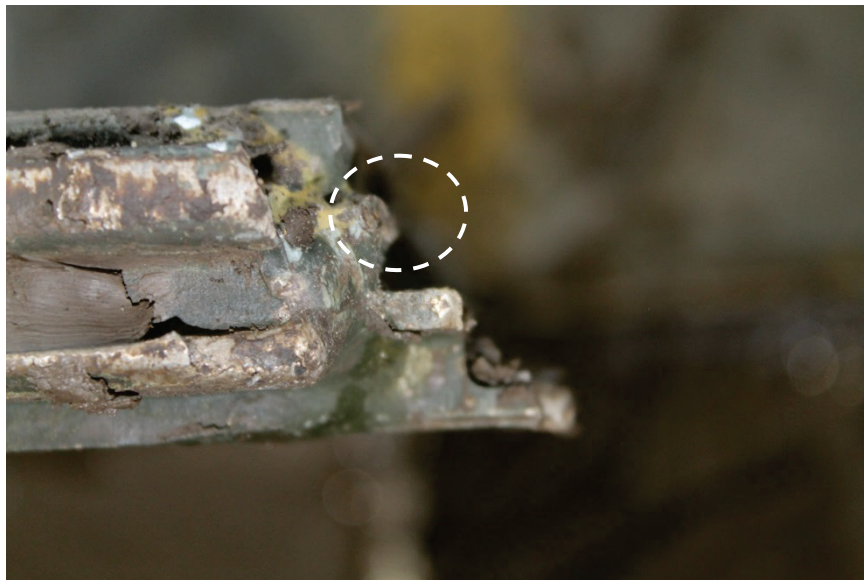
Figure 4.6. Broken upper underlap rail in G58.

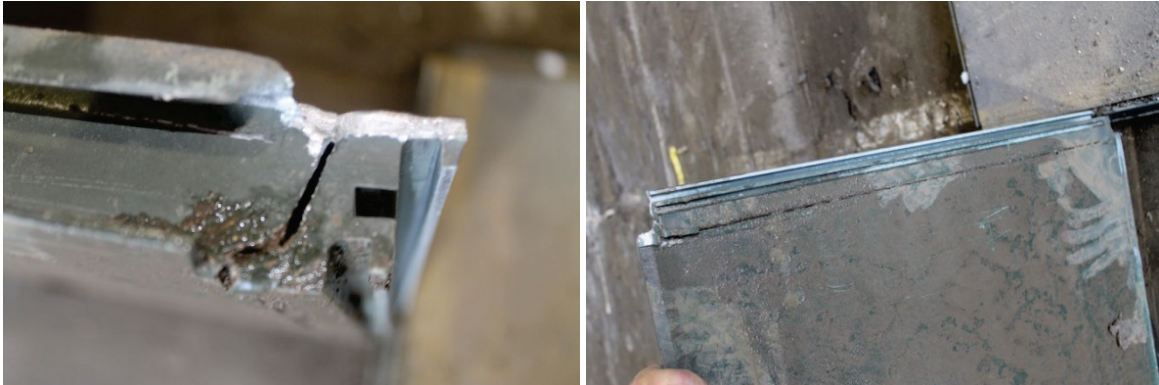
Figure 4.7. End connector weld failure at G23.

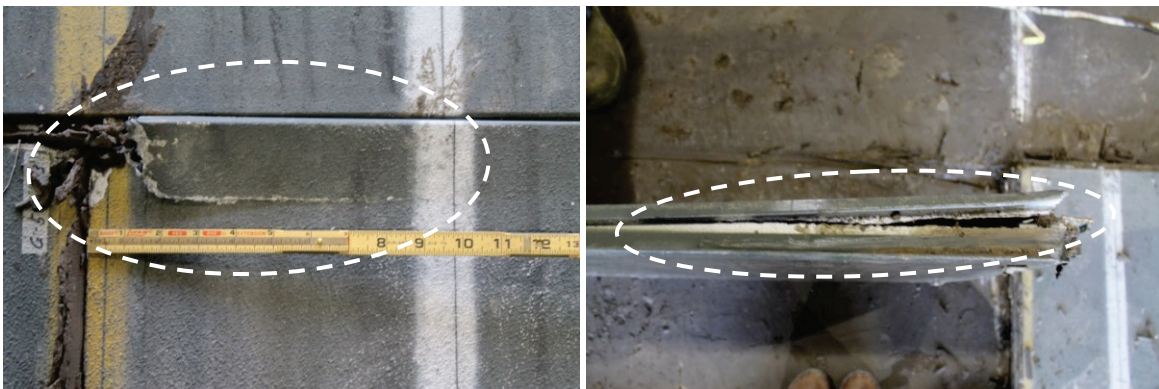
After pass 429, the upper under lap rail of Panel G46 broke, and Panels G23 and G59 had a small piece of the corner of the top skin chip off. After 476 passes, G59 had a top skin tear that was curled back a width of 2 in. along the weld and a length of 16 in. along the top flange of the female hinge, but had cracked a length of 9 in. (Figure 4.8). A vertical separation at the joint of G34 and G35 was noted, indicating breakage of a rail at one or both of the panels. Traffic was stopped due to tire hazards present throughout the lane.

Figure 4.8. Top skin tear in G59.

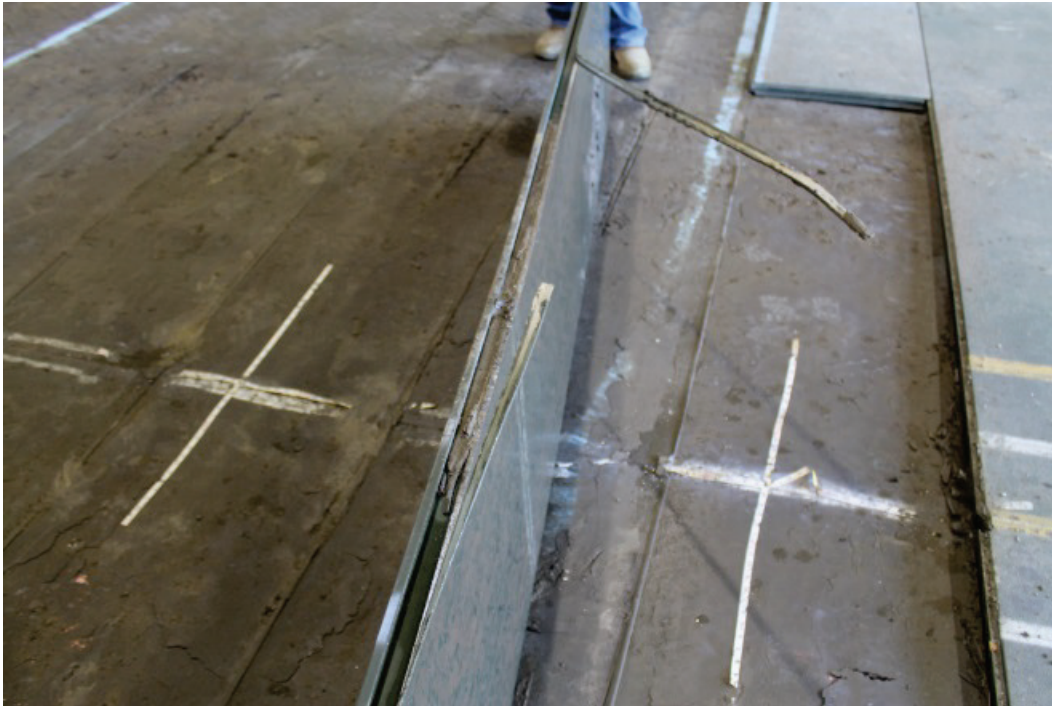
When panels were removed after trafficking was completed, additional damage was noted. The upper underlap rail of G34 broke a length of 10 in., starting at the north edge. However, since the length of breakage was less than 12 in. (half the length of the end connector), the panel was not considered failed. The bottom flange of the female hinge tore a length of 60 in. along the center of G65 (Figure 4.9). Panel G107 developed cracking at the weld of the overlap end connector, from the top surface to the bottom surface (Figure 4.10). Panel G71 had minor cracking at the southeast corner below the top flange of the female hinge connector. Table 4.2

Figure 4.9. G65 after removing from test section.

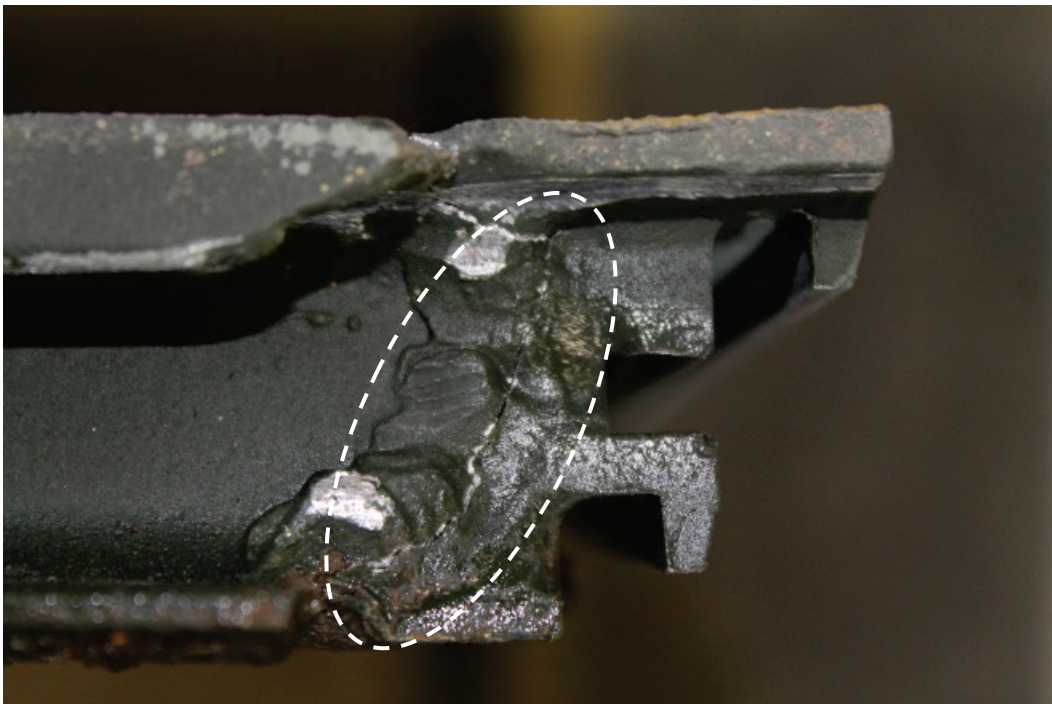
Figure 4.10. Crack at weld of overlap connector in G107.

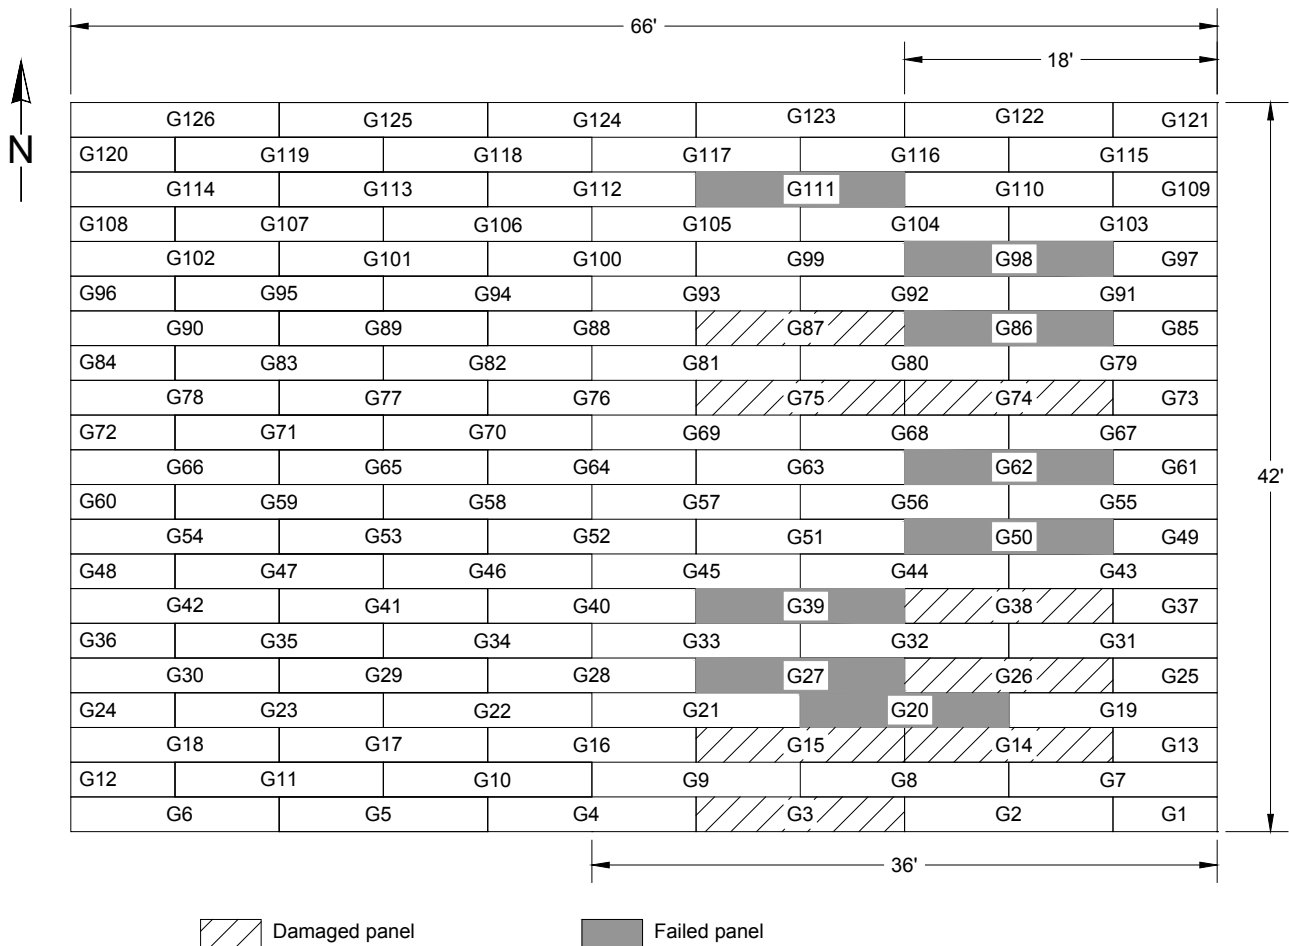
Figure 4.11. Layout of damaged and failed panels in the C-17 item.

No panel damage was noted until 168 passes were reached. Panel G50 and G62 each had the upper underlap rail break, which was evident from cracking visible on the north end at the upper underlap rail. Several panels had a slight corner curl in the south corner on the centerline of the traffic lane. After 308 passes, vertical separation was noted at many of the centerline joints, indicating failure of several rails. Traffic was stopped to prevent instability of the load cart.

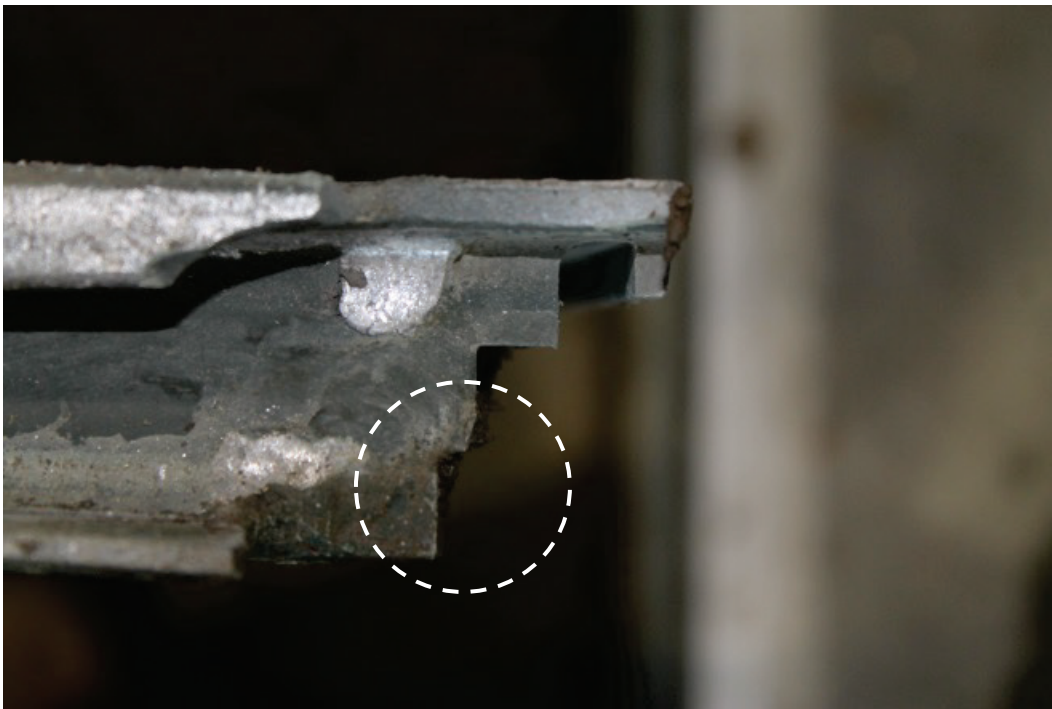
Figure 4.12. Lower overlap rail failure in G111.

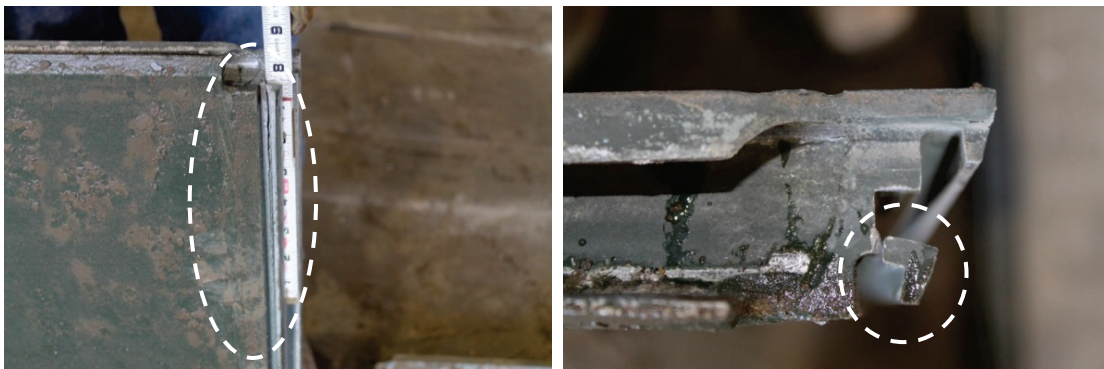
Figure 4.13. Partial breakage of lower overlap rail in G33.

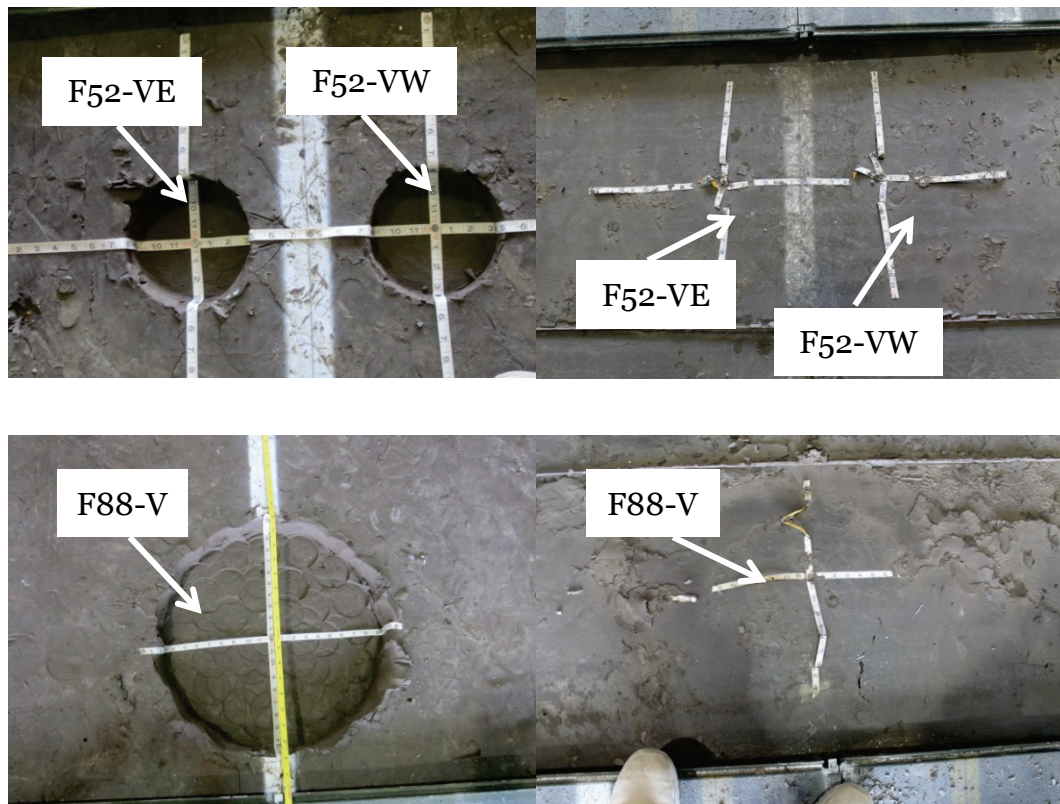
Figure 5.17. Pretest (a,c) and posttest (b,d) voids.
